Manhole Inspection Summary

Manhole # S35GG_016MH

Insp Date: **10/29/08 12:50 PM**

Location Address: **1401 CHARLES ST**

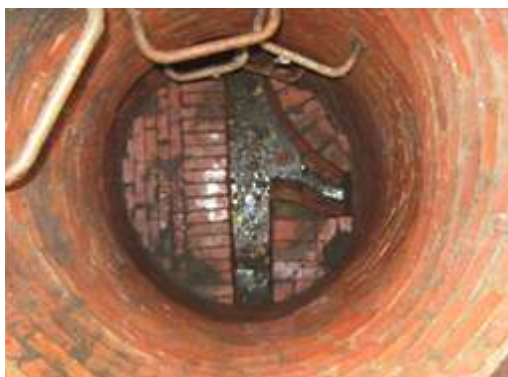
Top View

Corroded steps. Evidence of surcharge - Bench debris. Channel debris.

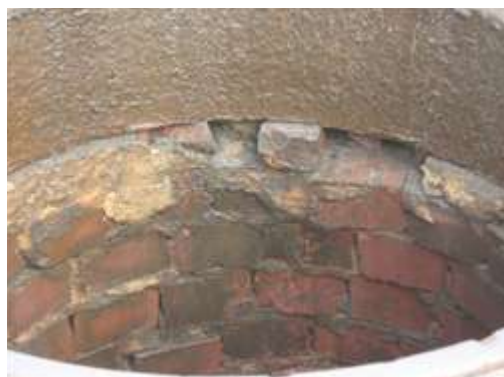
Defect

Frame leaks. Adjustment deterioration, loose brick and infiltration.

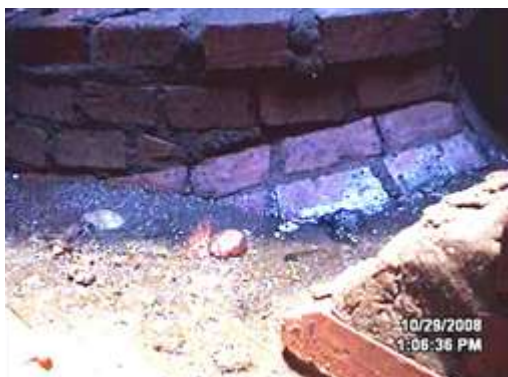
Defect

Channel deterioration.

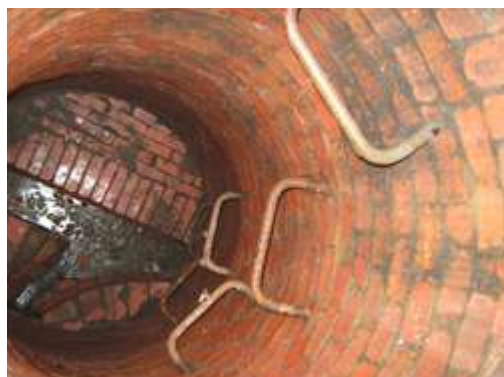
Defect

Adjustment, Corbel and Barrel infiltration.

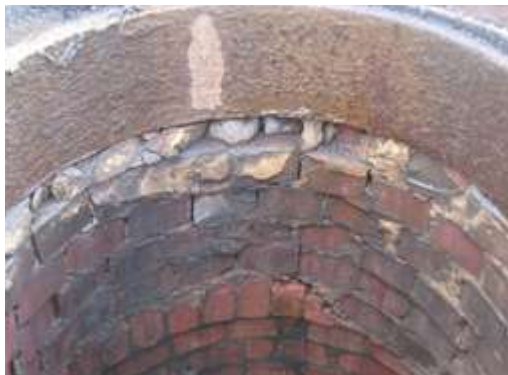
Defect

Frame leaks. Adjustment and Corbel deterioration and infiltration.

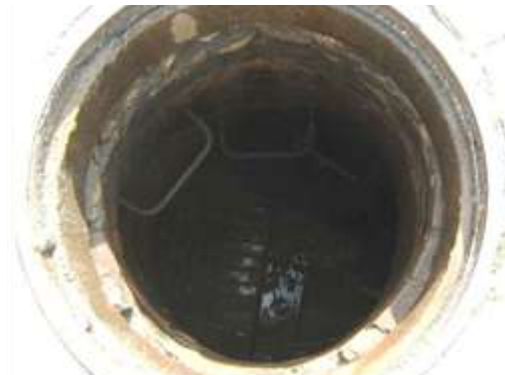
Defect

Frame leaks. Frame offset. Adjustment deterioration and infiltration.

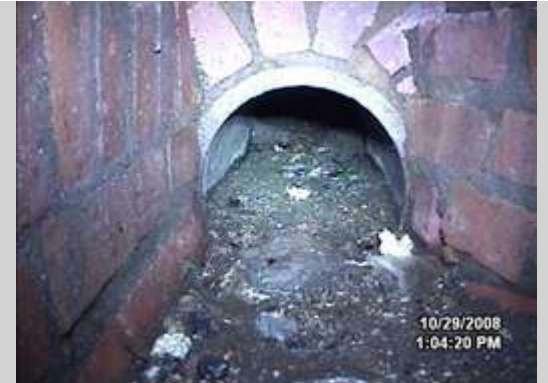
8 in. Circular Gravity Sewer Pipe Out @ 12 O'Clock

Deposits: ☐ None ☒ **Mud** ☐ Sludge ☒ **Debris** ☐ Grease

Silt Depth: **2** (in.) Deposits Extent: **Medium**

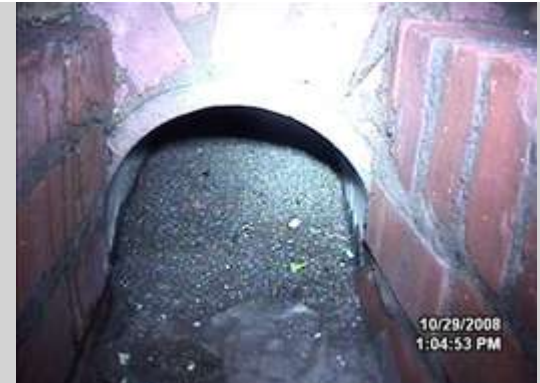
8 in. Circular Gravity Sewer

heavy sediment in channel

Deposits: ☐ None ☒ **Mud** ☐ Sludge ☒ **Debris** ☐ Grease

Silt Depth: **2** (in.)
